### **Using a Dallas/Maxim DS1811 in the Reset Section.**

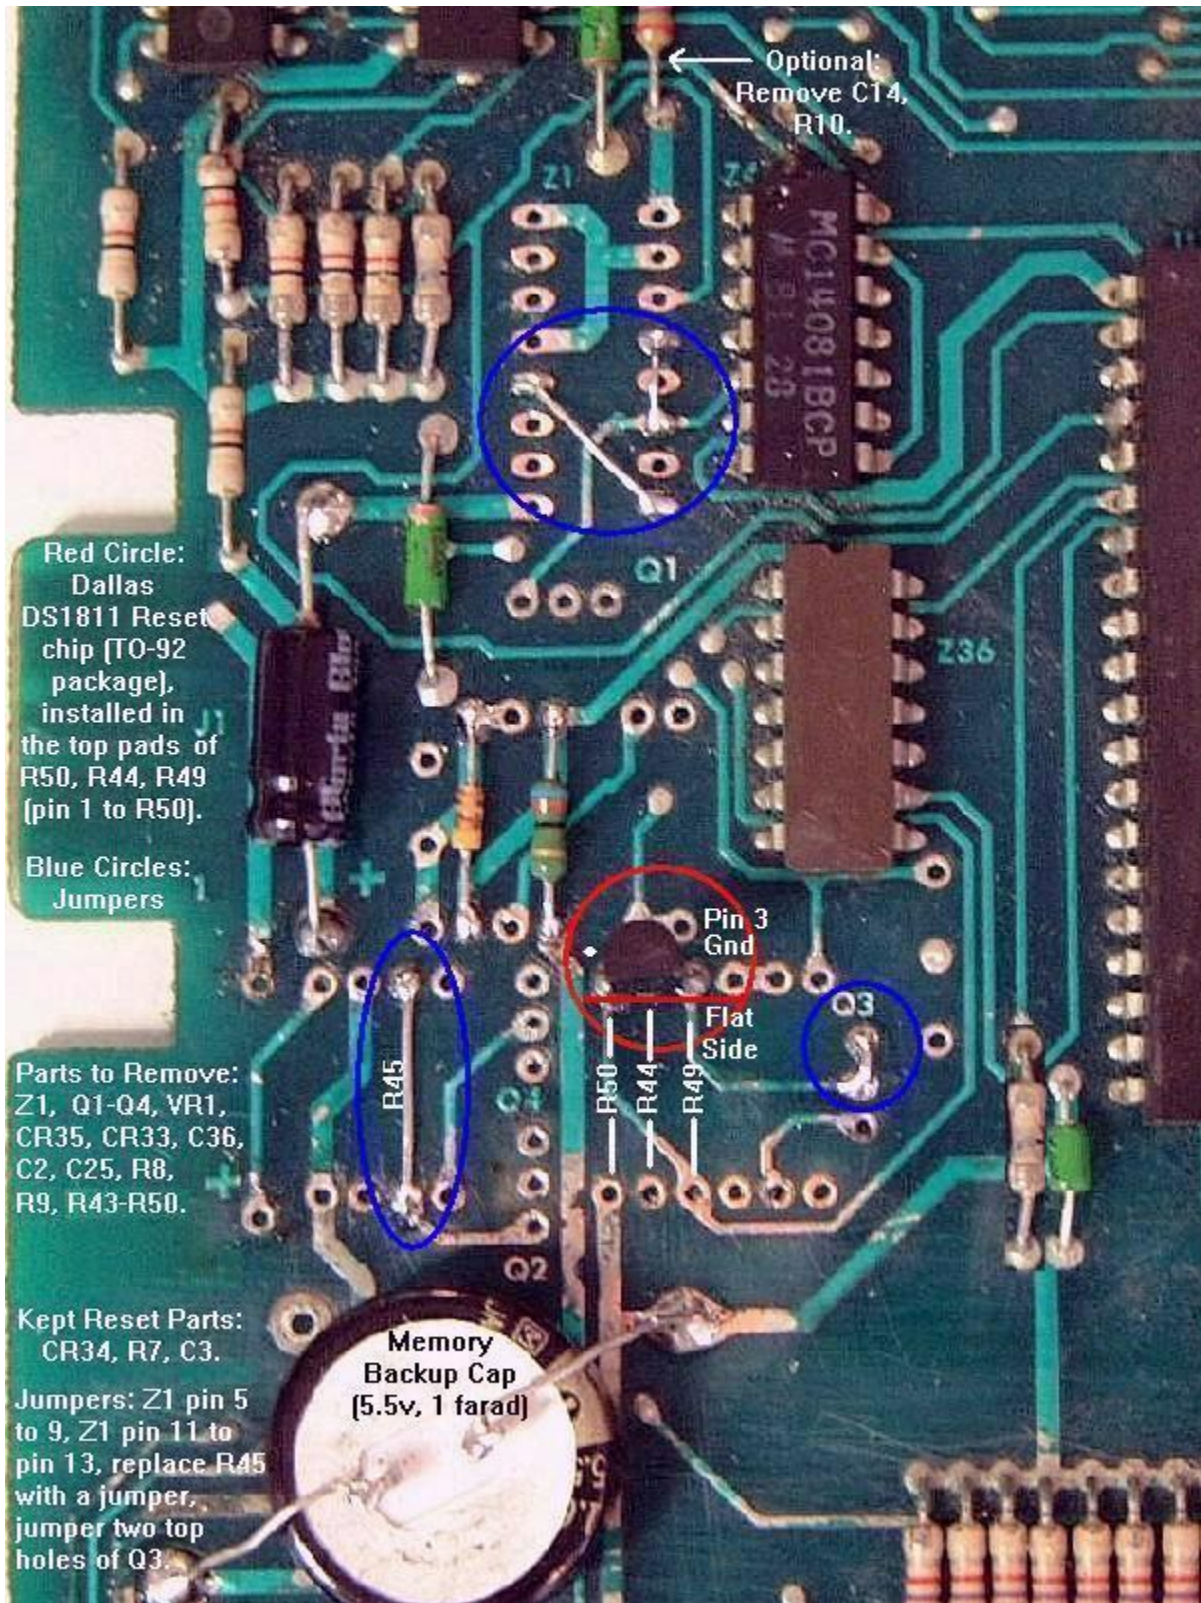
Picture of the Dallas DS1811 installed in the Sys80 CPU board.

- Remove reset parts: chip Z1, trans Q1-Q4, diodes CR33, CR35, VR1, resistors R8, R9, R43-R50, caps C2, C25, C36.
- Install a jumper from Z1 pin 5 to Z1 pin 9.
- Install a jumper from Z1 pin 11 to Z1 pin 13. Be careful not to accidentally connect pin 12 to the jumper, as it will cause the reset modification to not work.
- Install a jumper where R45 was installed.
- Install a jumper between the two top holes of Q3 (the Emitter and Base).
- Install the Dallas DS1811 (TO-92 package) into the top pads of R50, R44, R49 (pin 1=R50, pin 2=R44, pin 3=R49). Note the flat edge of the DS1811 faces downward away from Z1, toward the dip switches.
- Retain reset parts CR34, R7 and C3.
- Note R10 and C14 can be removed or left installed. Since Z1 has been removed, R10 and C14 are no longer used, and can be removed (or left installed).

The DS1811 is installed with pin 1 going to /RESET, pin 2 to +5 volts (thanks to the jumper at R45), and pin 3 to ground (via the jumpered Q3). A picture of all the removed parts and the DS1811 and jumpers installed can be seen below. Also remember using the DS1811 will not replace the often damaged clock circuit chips at Z2 and Z3.

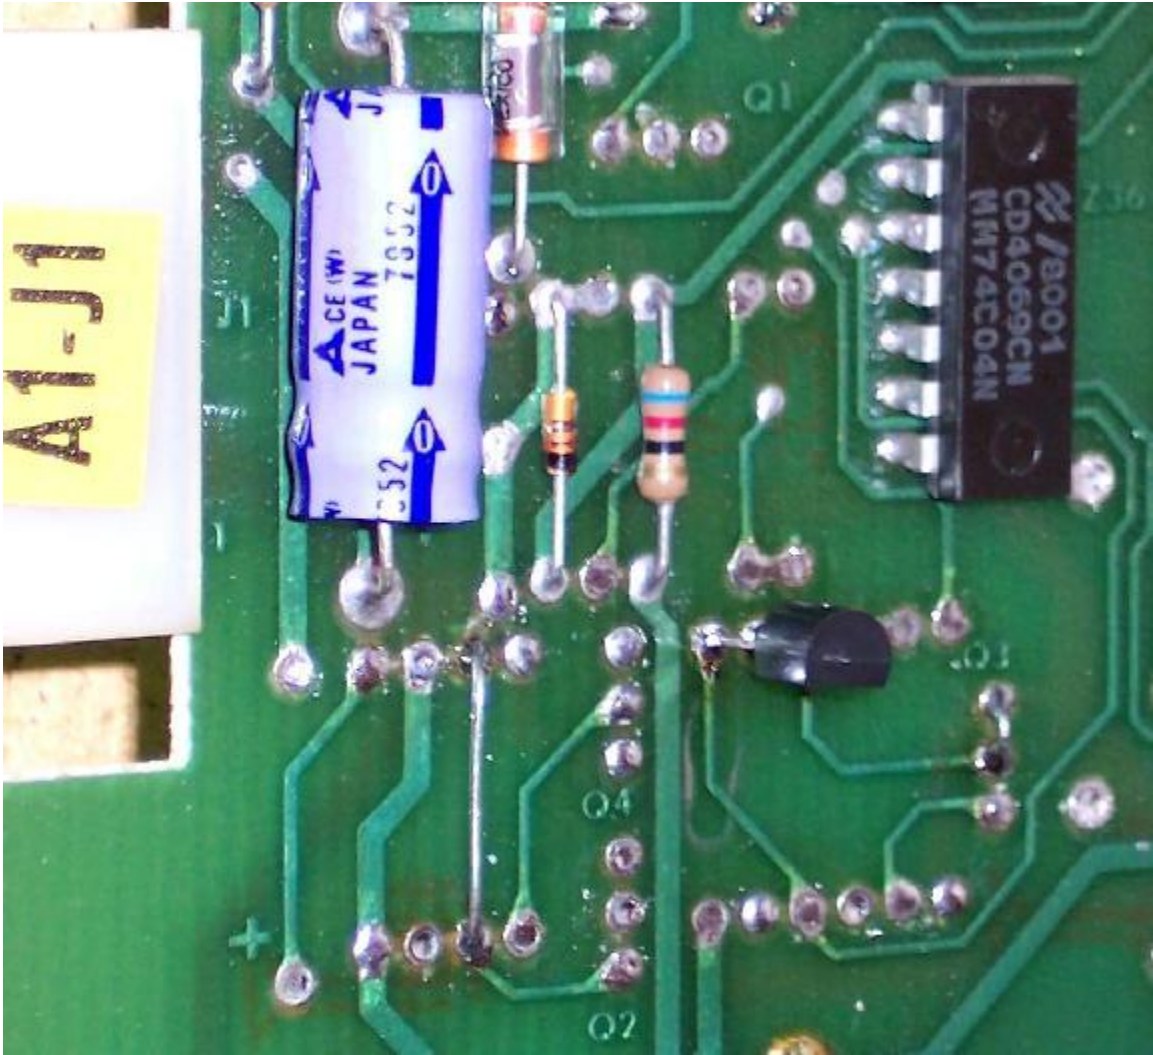
The Dallas DS1811 installed in the Sys80 CPU board (picture by Neil Bradley).

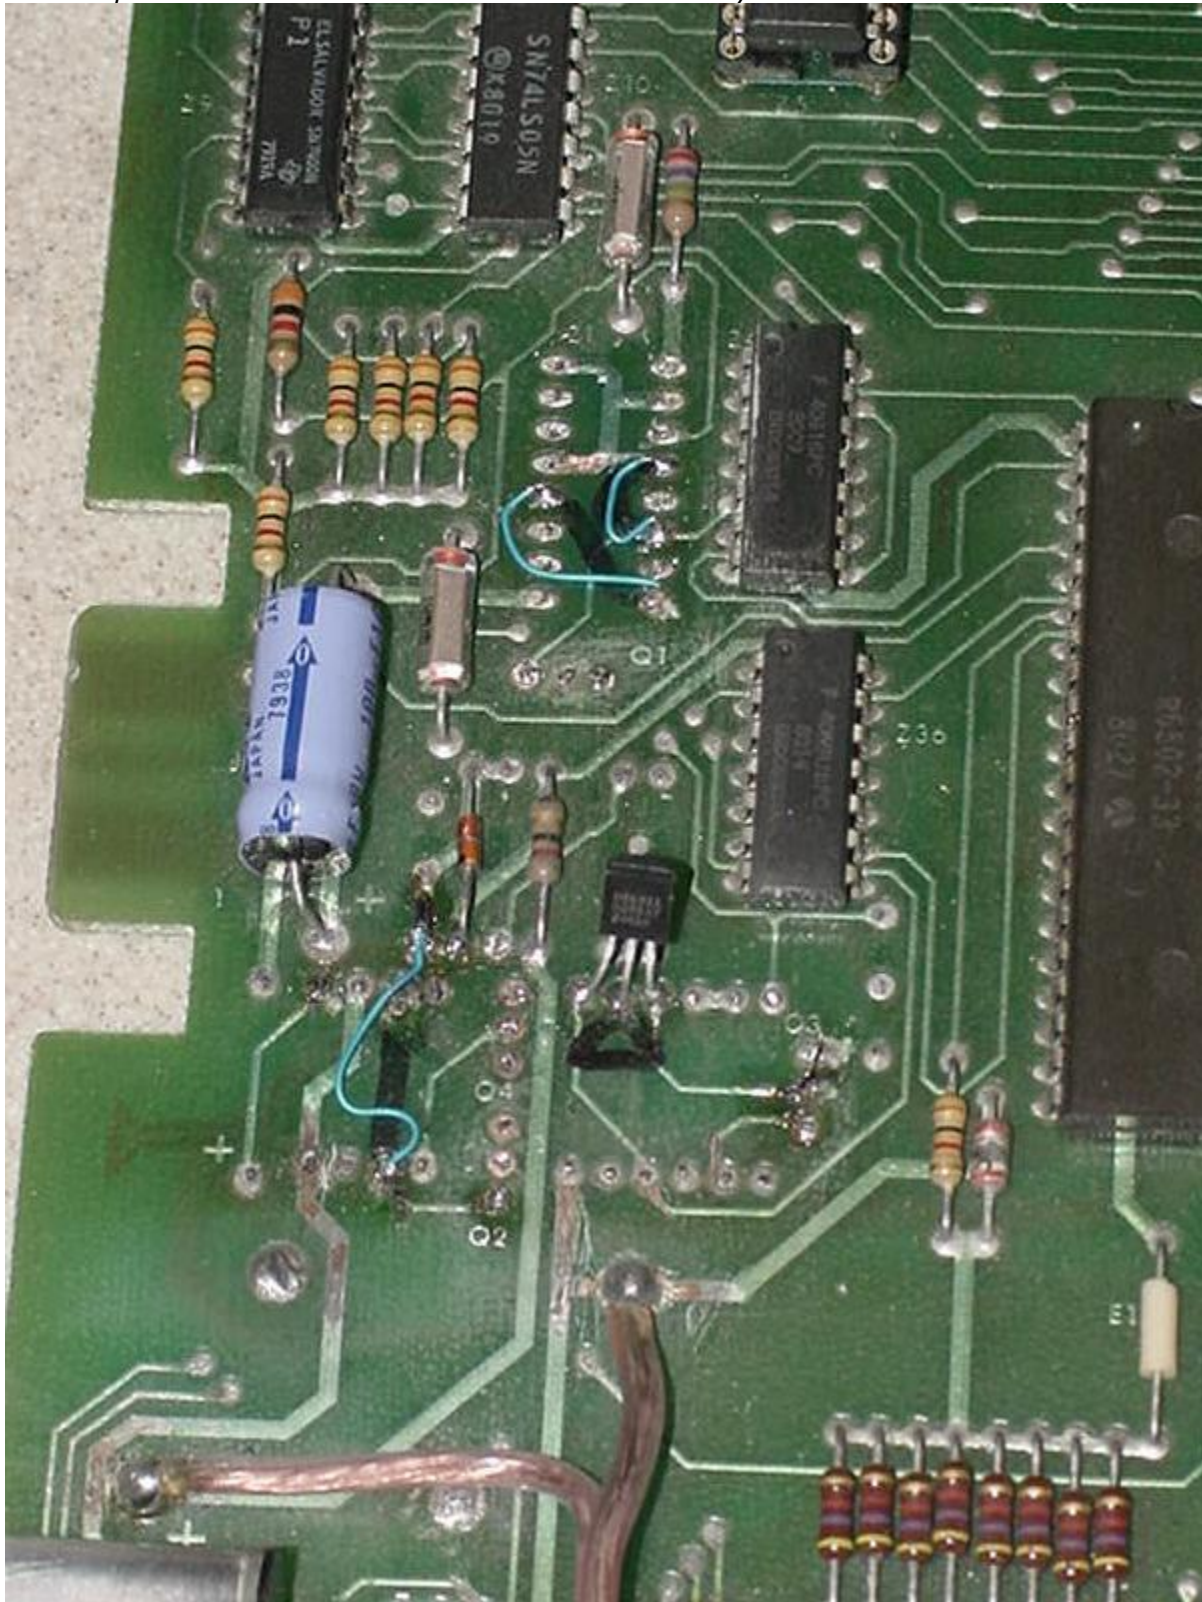
Another picture of the Dallas DS1811 installed in the Sys80 CPU board.
